Hydrologic report for proposed  
Corop solar farm

19 August 2019

# Technical report for Leeson Group

## Hydrologic report for proposed Corop solar farm

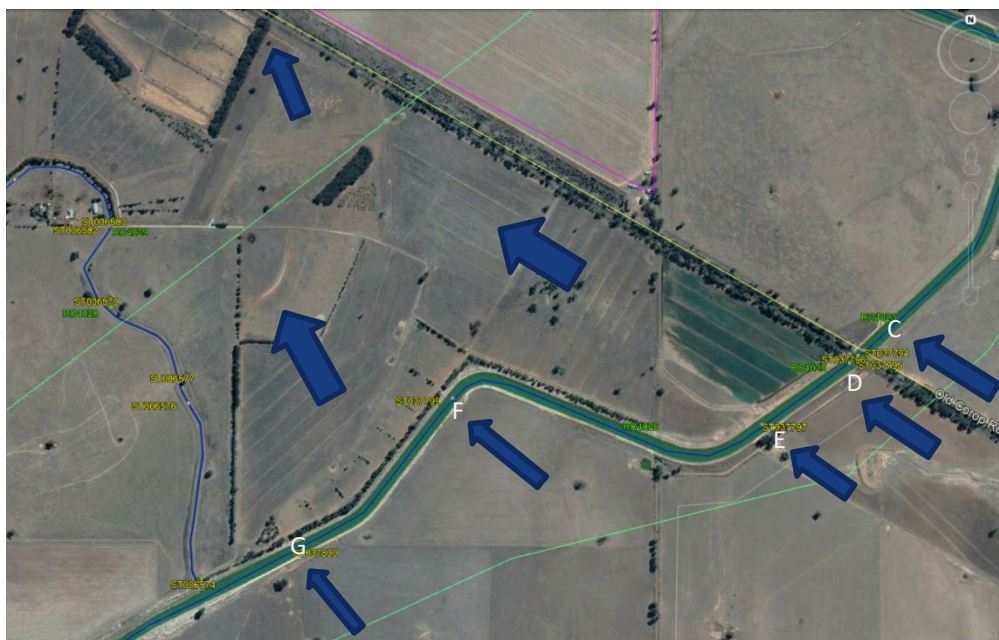
Figure 5: Current overland flow into/from water control structures

Note: Sites C, D and E are located along the main flow path adjacent to Old Corop Road (see Figure 5).

The primary rainfall runoff path towards the site is along the southern side of Old Corop Road. North of the Waranga Western Channel the runoff is confined to the property between Corop Road and the GMW No 11 channel (Figure 5). Water then spills into the property of interest at the floodway opposite a recycle dam on located on the southern side of Old Corop Road (Figure 6 for photos of water entry points). This location is nominally the origin of the Woolwash depression. This general water flow arrangement is confirmed through the planning overlays which show an LSIO overlay along the Old Corop road extending into the property.

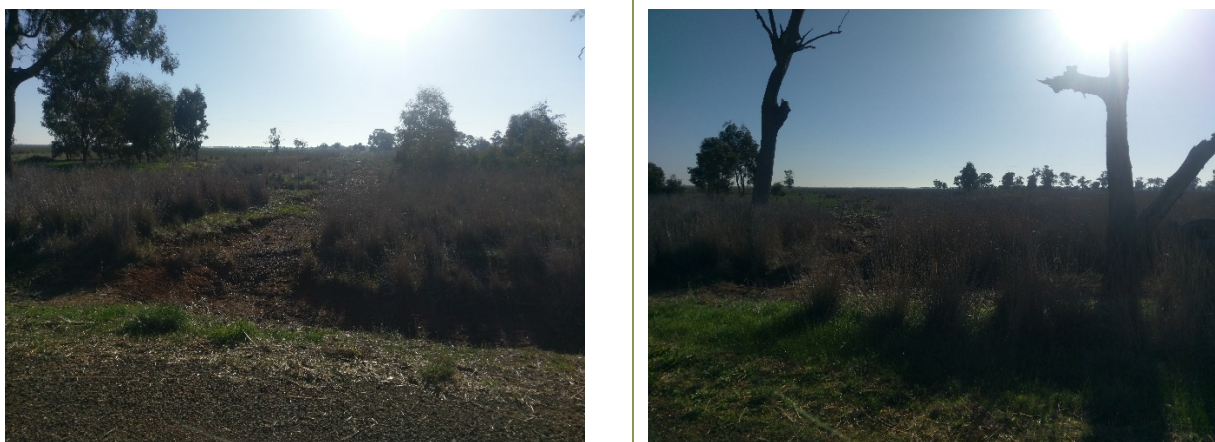
*Figure 6: Water entry points to property from Old Corop Road*

A site inspection was also completed on 13<sup>th</sup> May 2019 and it is evident from visible features throughout the property that it has a number of characteristics that are specifically configured for managing drainage and flooding. These are described further in following sections. Whilst general connectivity of waterways is maintained through the property, there are some clearly defined earthen embankments that enable runoff to be directed to manage on-farm production. These and other features form part of the description of how the land is currently used and could be adapted to an alternate land use for both normal climatic regimes and flood regimes.

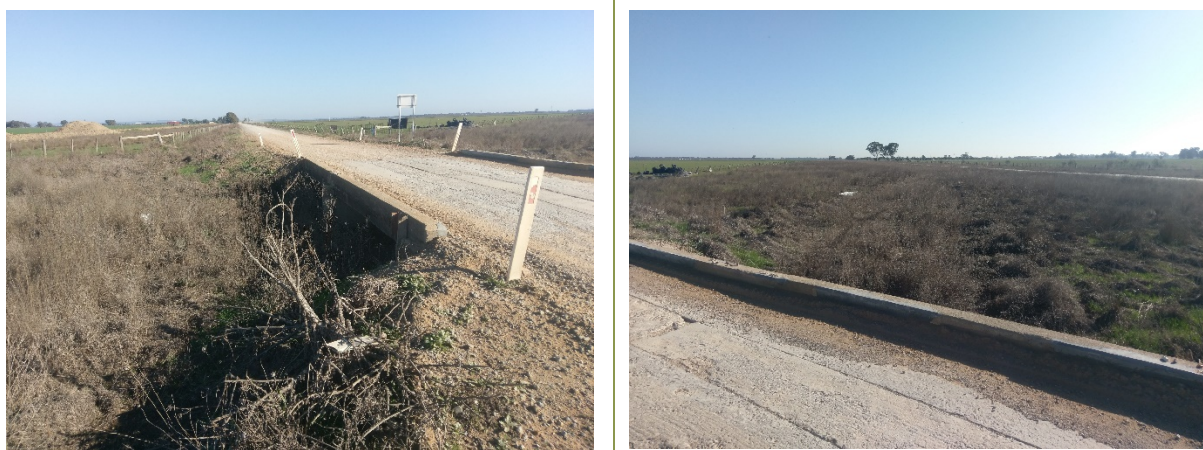
*Figure 10: Downstream flood infrastructure [box culvert (left) and downstream of culvert looking north west (right)]*

Analysis of natural surface levels along the Carag Road (and along the Woolwash depression) show that there is little to no relief once water passes downstream of Bedwell Road. Downstream of the northern property boundary there is a double box culvert under Carag Road and a defined, albeit shallow and flat, floodway (Figure 10). Other sub-catchments also discharge water to the area upstream of the Carag Road culvert. The size of this culvert indicates that substantial water movement occurs along Carag Road.

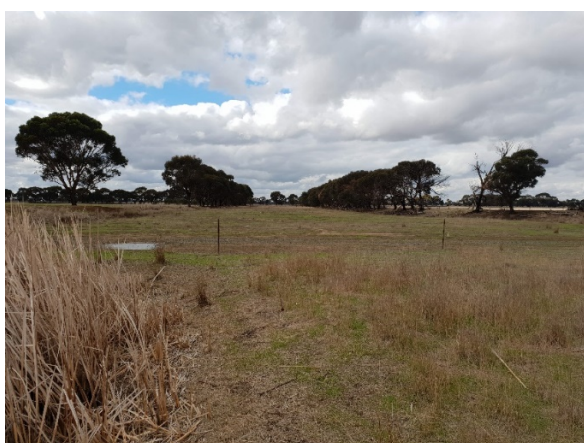
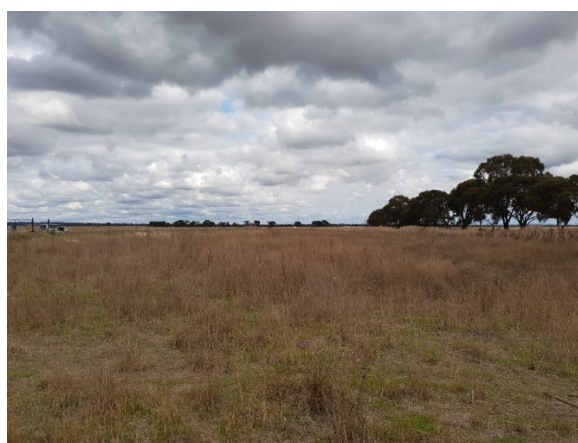
*Figure 11: Woolwash depression photos*

Eastern arm Woolwash depression – looking north Bedwell Road

Western arm Woolwash depression – looking south towards Bedwell Road

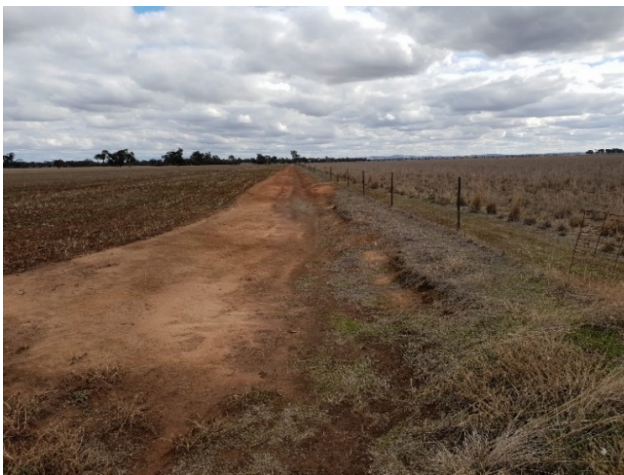
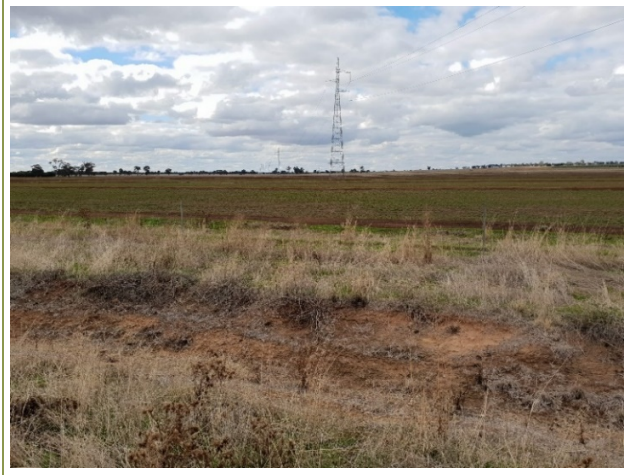
*Figure 17: Examples of the form of existing drainage lines on property*

Internal drainage commencement– eastern boundary – southern block

Internal drainage mid -section, southern block – note scouring

The existing farm layout on the southern portion of the property is configured with a number of features to manage excess water across the property. Drainage lines along the centre and eastern flank (Figure 17) of the property are clearly designed to convey water on natural grade to a discharge point at Bedwell road (Figure 18) where the Woolwash depression commences. An analysis of daily rainfall data for the 2010 / 11 event indicates that the peak daily rainfall was around 90mm. Based on the catchment area this could result in runoff in the order of 150ML/d.

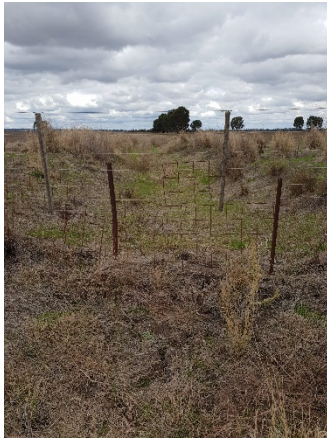
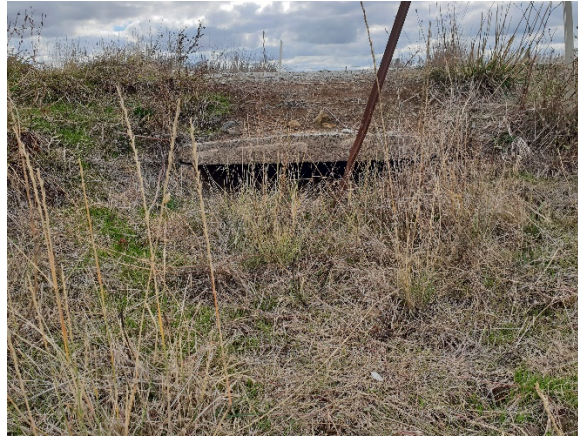
*Figure 18: Engineering works at Bedwell Road*

Existing drain leading up to Bedwell Road (photo looking south from Bedwell Road)

Internal drainage mid -section, southern block – note scouring

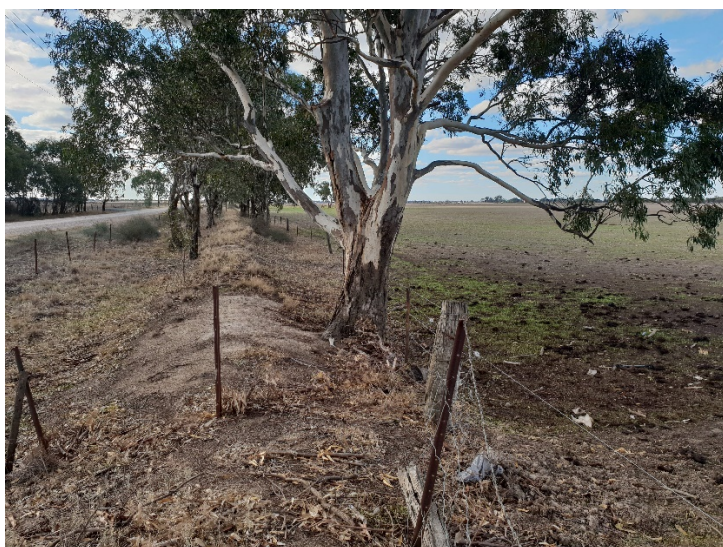
Figure 19: Geodetic Road works (internal embankment on western boundary)

Currently there are two internal pump locations on the northern block discharging into the Woolwash depression; one on the eastern and one on the western flow path. These discharge points remove water via an internal drainage network implemented to protect agricultural assets from water logging (namely broadacre crops, sheep, cattle). The property is also protected by a small earthen embankment on the western side running parallel with Geodetic road. This embankment protects the property from south western flows

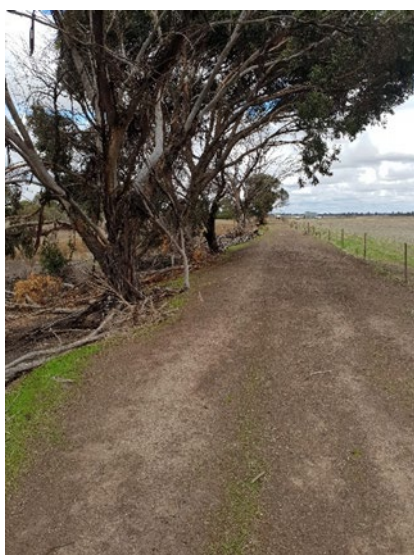
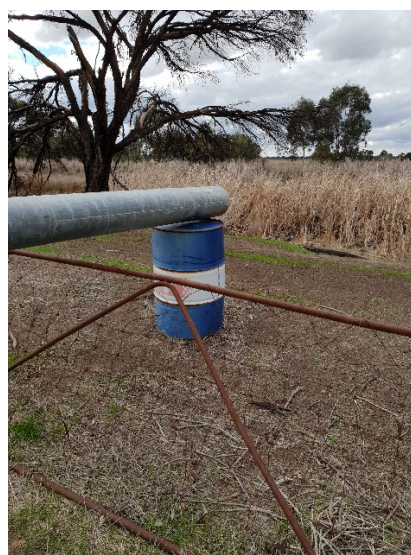
Figure 20: Engineering works at Bedwell Road

Eastern embankment and access track mid-section of northern block (looking north, depression on left, farm layout on right)

Discharge point into Woolwash depression eastern boundary

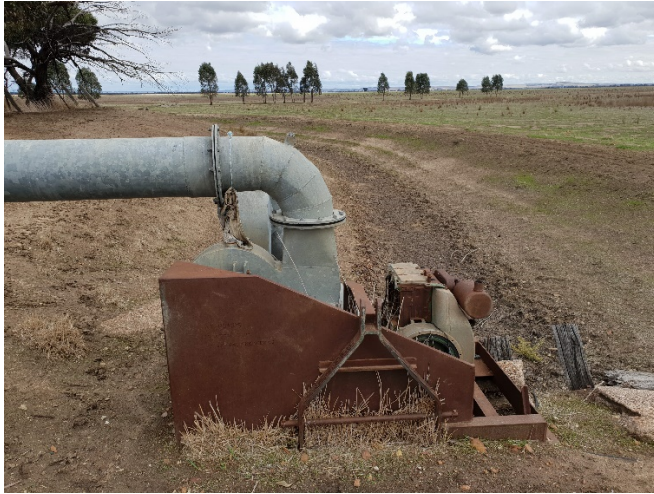
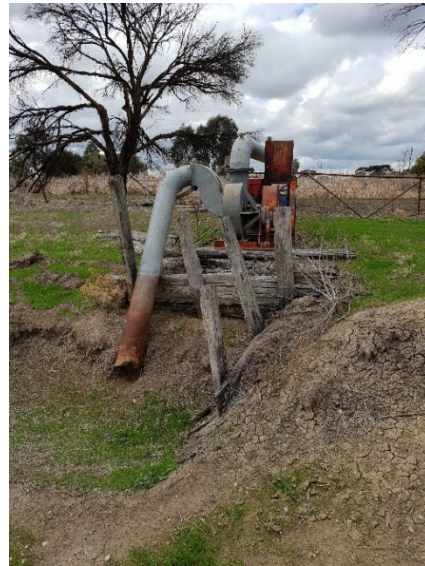
*Figure 21: Discharge point to Woolwash depression*

Internal drainage leading to pump on Western arm of depression

Discharge point into Woolwash depression  
eastern arm (located on western boundary)

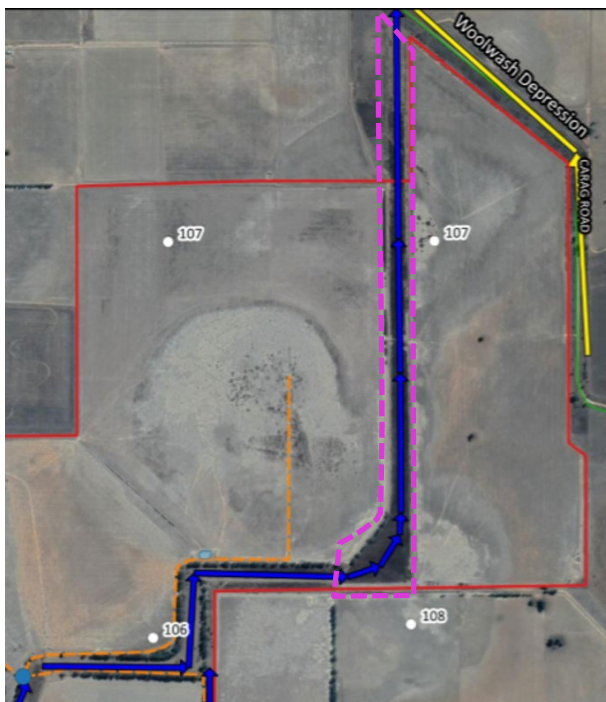
- 60109 – Part of the Woolwash depression immediately upstream of Carag Road (pink dashed outline)
